# Manhole Inspection Summary

Manhole # S13Q\_\_020MH

**Location** Address: **3100 Wilkens**

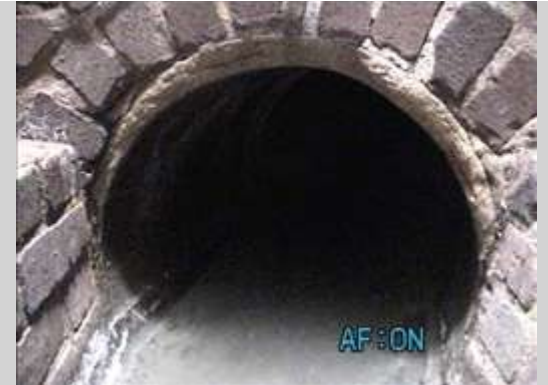
12 O'Clock Outflow

18 in. Circular Gravity Sewer  
Pipe Out @ 12 O'Clock

Pipe Height: **18** (in.) Rod and Bar (Angled)  
Pipe Material: **Concrete** ☐ Pipe Lined  
Invert Depth: **11.64** (ft.) Flow Characteristics: **Fast**  
Deposits: ☒ None ☐ Mud ☐ Sludge ☐ Debris ☐ Grease  
Silt Depth: **0** (in.) Deposits Extent:  
Infiltration: **None** Pipe Seal Cond: **Sound**

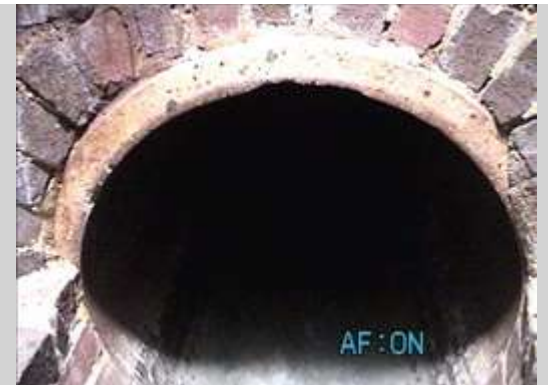
5 O'Clock Inflow

18 in. Circular Gravity Sewer  
Pipe In @ 5 O'Clock

Pipe Height: **18** (in.) Rod and Bar (Angled)  
Pipe Material: **Concrete** ☐ Pipe Lined  
Invert Depth: **11.15** (ft.) Flow Characteristics: **Fast**  
Deposits: ☒ None ☐ Mud ☐ Sludge ☐ Debris ☐ Grease  
Silt Depth: **0** (in.) Deposits Extent:  
Infiltration: **None** Pipe Seal Cond: **Sound**
